Case Study: Compacted Embankment Landslide in Grady County, Oklahoma

by A.B. Cerato¹, R.C. Oleski², C.C. Puklin³

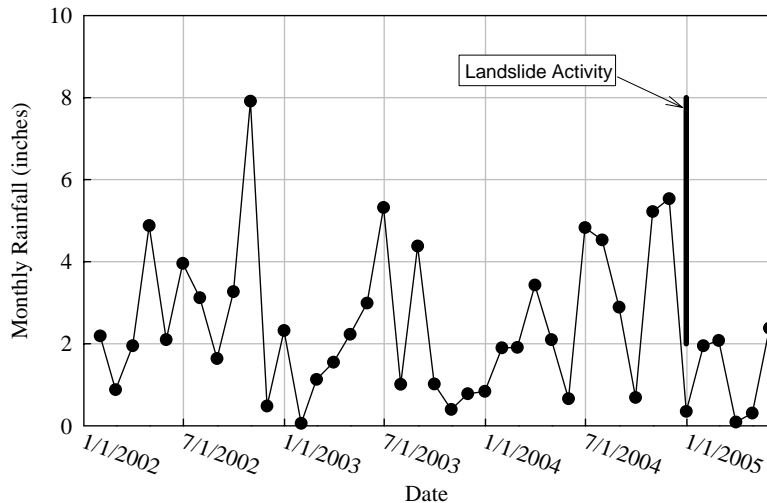
Figure 2: Monthly Rainfall for Grady County, Oklahoma.

13 inches dry of average at 22 inches of rainfall. In October and November of 2004 there was a total rainfall of 10.75 inches. Then in December, 2004, the rainfall total was 0.35 inches. The landslide is assumed to have occurred in late December 2004 or early January 2005. The specific date is unknown.

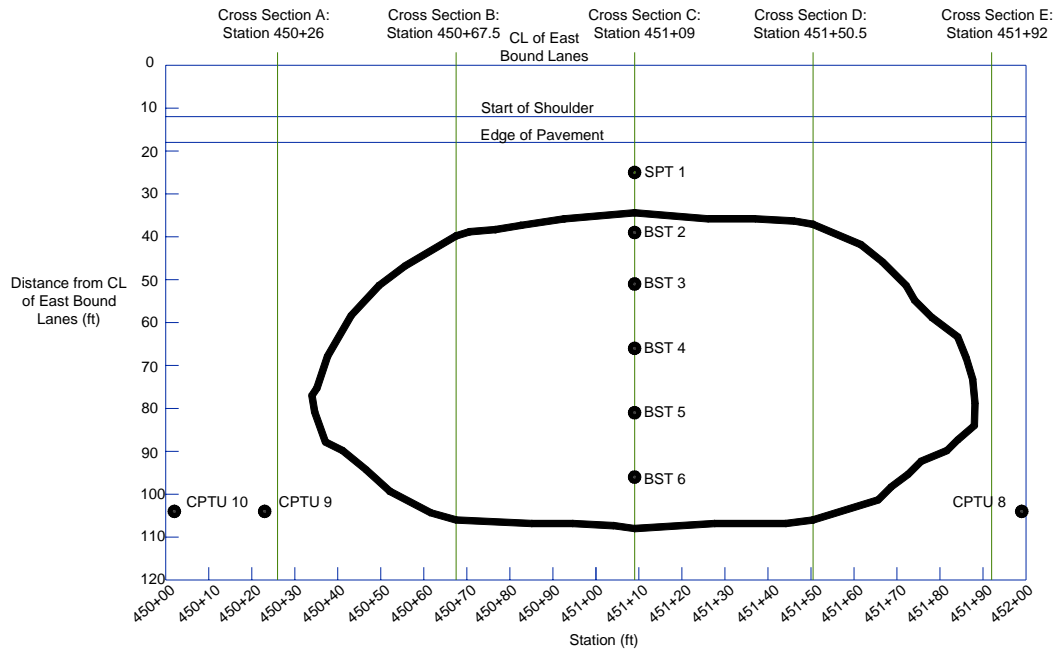
Figure 3: Plan View of Chickasha Landslide, Grady County, OK.

The embankment was surveyed in five cross sections and was found to have an average slope of 2.5:1 (22.5°). The landslide extent was found to be approximately 74 feet from the top of the scarp to the toe and 152 feet across (Figure 3). The field investigation revealed a significant amount of tension cracks in the slide mass; some of which were found to be filled with water. Numerous hand auger borings were found to have perched water levels as well. The landslide was recognized as a rotational slide from the existence of a vertical scarp and base debris. The failure surface of the landslide was determined using the friction circle method. This method is useful for homogenous soils with $\phi_u > 0$ and may be used when both cohesive and frictional components for shear strength have to be considered in the calculations. Once the failure surface was determined, the ordinary method of slices was employed to determine a backcalculated friction angle of the slide assuming a factor of safety (FOS) of 1 and cohesion equal to zero. A further assumption is made that since the slide has been recurring the operating shear strength along the failure surface approaches a value at or near the residual shear strength ($\phi_r, c=0$). Rotational slides in soils generally exhibit a ratio of depth of the surface or rupture to length of the surface of rupture (d/L) between 0.15 and 0.33 (Skempton and Hutchinson 1969). This slide had a d/L ratio of 0.28 (21 ft./74 ft.).

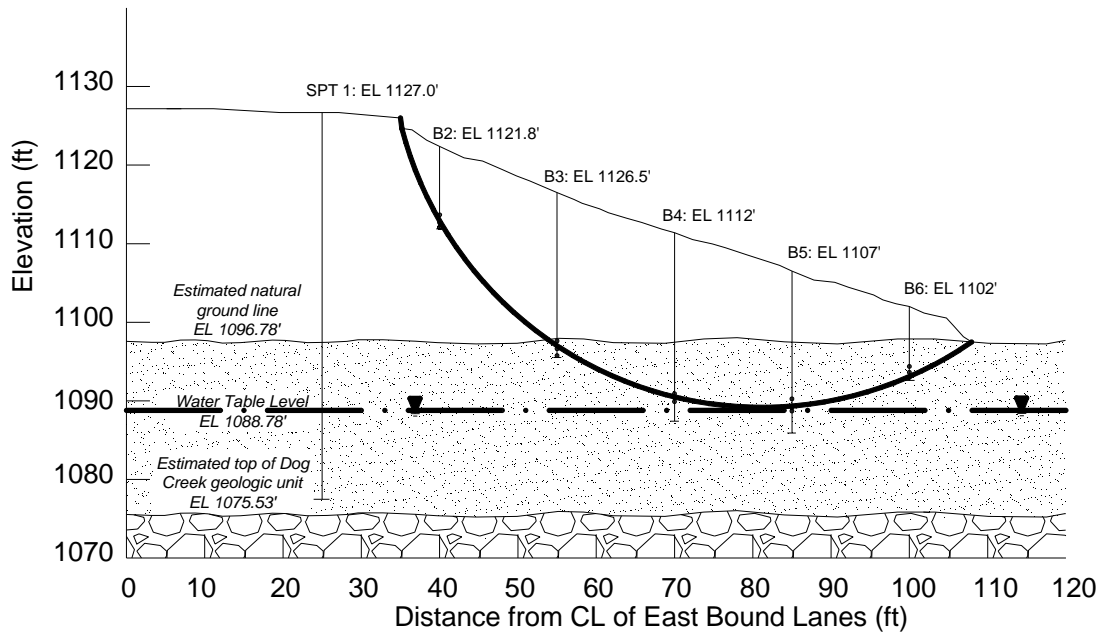
Figure 4. Profile of Cross Section C showing the landslide extent, depth of hand-augered holes and location of Borehole Shear Tests (BST).

performed in each of the auger holes just above, at and just below the failure surface of the slide to determine the drained peak friction angle of the soil. The locations of the BSTs are shown as points along the hand-augered holes (B2-B6) in Figure 4 and the depths and results of the tests are presented in Table 1. The borings were then continued until refusal. Thirteen electronic friction cone and piezocone soundings (ASTM D5778-00) were also performed across the embankment, however only the closest three piezocone tests to the landslide are shown. The embankment was too steep for the cone truck to drive across and maintain a level working platform, therefore there are no piezocone soundings on the landslide.

Carbonates act as a cementing agent in soils which increases the shear strength as long as they remain unsaturated. However, when carbonates are inundated with water, they weaken and may cause sudden settlement, collapse or sliding of the soil deposit. The 10.75 inches of rain in the 2 months prior to the slide could have initiated the slide along the existing shear plane by elevating the water table which is located close to the failure plane and in the existing soil material. The progressive slide surface weakens with the inundation of water and slips along the circular path, therefore the slip plane can be delineated by the sudden decrease in carbonate content along the length of the slide. As can be seen from Figure 4, the slide recurs through the compacted fill and into the existing native soils.

The Oklahoma Department of Transportation Department's (ODOT) Materials Division recommended that a z-section sheet pile wall be driven across the length of the embankment to refusal to ensure the slide does not encroach on the Boles-Holms subdivision residents. The sheet pile will intercept the rotational slip plane and stop the recurring landslide from sliding again. The completed grade of the sheet pile wall will be raised to such a point that the embankment slope can be flattened to a 3:1 slope. The sheet pile will be curbed to improve the aesthetics and protect the sheet pile.

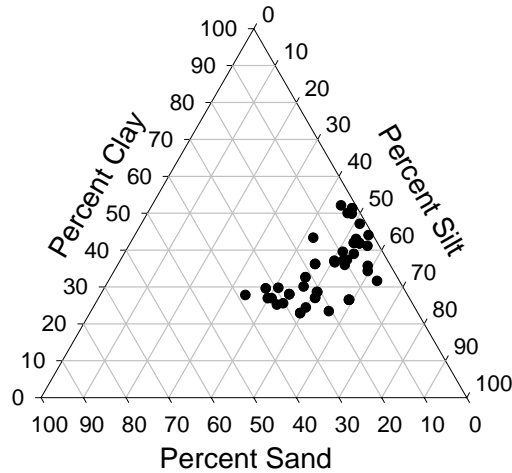
Figure 5. Ternary Diagram of soils in embankment.

The results of the laboratory investigation of the soils in boring 4 along cross section C show that the site generally consists of lean clays (CL) with some layers of fat clay (CH). A summary of the grain-size characteristics is presented on the ternary diagram shown in Figure 5.

As can be seen, there is a tight distribution of individual grain-size characteristics and the majority of the samples classify as “fine-grained” with more than 50% passing the No. 200 sieve. The clay size fraction ranged from 23 to 52%. Figure 6 shows the location of the samples on a Casagrande Plasticity Chart.

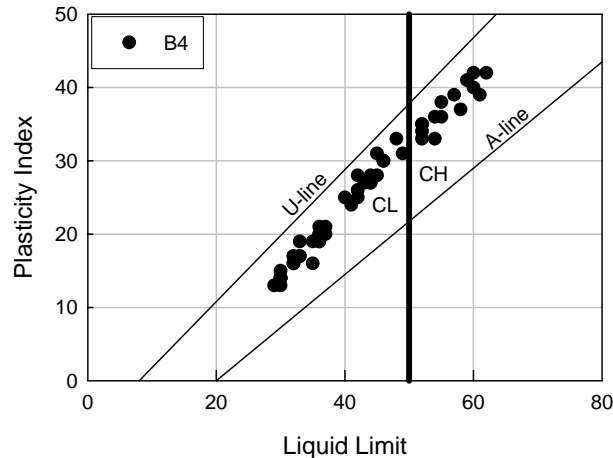
Figure 6. Plasticity Chart.

LL values ranged from 29 to 62% and PI ranged from 13 to 42%. Total SSA ranged from 25 to 188 m²/g. Skempton’s activity, $A = PI/CF$ of the soil ranged from 0.4 to 1. The Skempton (1953) activity values for kaolinite, illite and Na-montmorillonite are 0.38, 0.9 and 7.2 respectively. Most natural soils, which are typically composed of mixed layer minerals, would fall somewhere between those values. From the A results of this study, the predominant mineralogy should be illite, however, a clearer method in delineating mineralogy is to use SSA, a more fundamental soil property than PI. The surface area activity, $S_c = SSA/CF$ ranged from 0.9 to 3.9. The average S_c for the soil deposit is 3. For a given CF, SSA increases according to mineralogy in the following order: kaolinite < illite < montmorillonite. Cerato and Lutenegeger (2005) presented S_c values of pure clays showing that kaolinite has a S_c around 0.4, illite has a S_c of approximately 3.3 and montmorillonite has S_c values above 5. Therefore, the SSA results conclude that the predominant mineralogy of the site is illite.

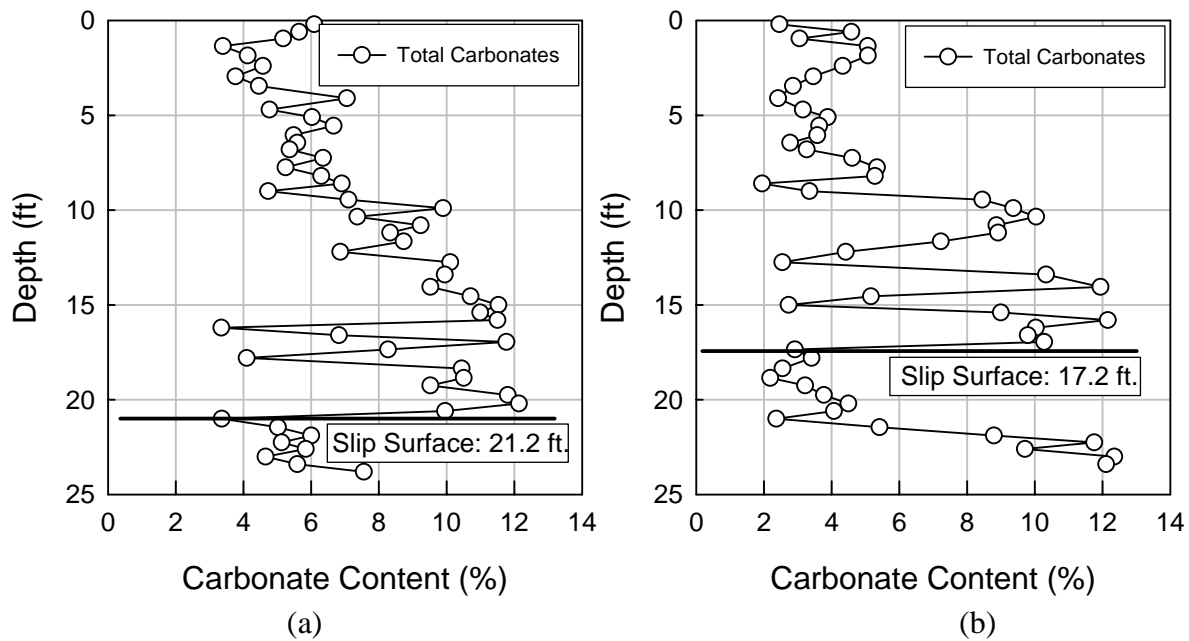
Figure 7: a.) Boring 4 Carbonate Content and b.) Boring 5 Carbonate Content with depth.

It was anticipated that the carbonate content of the soil would be relatively high due to the composition of the parent rock (Dog Creek shale) and it can be seen that the carbonate content at the surface of the embankment is around 6% and increases to 12% at 20 feet. Around 21 feet, where the failure plane is located, the carbonate content decreases immediately to 3.5% and then slowly increases to 7.5% at 24 feet where Boring 4C was terminated due to auger refusal (Figure 7). It is thought that the increase in carbonate content with depth is due to the leaching of the carbonates through the soil profile with rainfall infiltration. The depth of maximum carbonate content in boring 4C is where the slip surface was backcalculated to have occurred. In order to determine if this phenomenon held true throughout the slide, Boring 5C, just downslope of 4C, was tested for carbonate content with depth. Again, it was found that the slip surface could easily be seen in the profile at approximately 17 feet where the carbonate content decreased rapidly from 10% to 3% and then gradually increased above the bedrock.
