March/April 2009

Geo-Strata

Heave Distress Problems in Chemically-Treated Sulfate-Laden Materials

By Anand J. Puppala, Ph.D., P.E., M.ASCE and Amy Cerato, Ph.D., P.E., M.ASCE

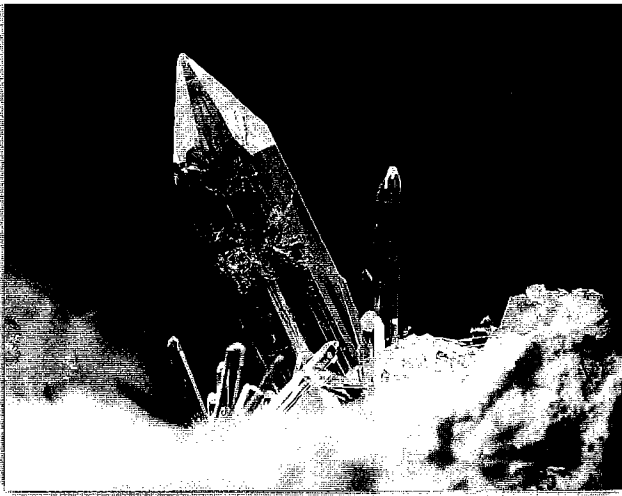
Figure 2. Ettringite crystal.

When sulfate-rich soils are treated with calcium-based stabilizers, the sulfates in the soils will react with the alumina (possibly in amorphous structure) liberated from the clay particles and the calcium component from the stabilizers to form a combination series of calcium-aluminum-sulfate hydrate compounds. These compounds will lead to the formation of ettringite crystals, which can expand to two or three times their original size when subject to hydration.

Once the ettringite crystal is formed, it continues to grow in almost pure form. The minerals will also expand due to continuous crystalline material growth. Both hydration reactions and crystal growth will result in a significant amount of heaving (reportedly up to 250 percent) in sulfate-rich soils.

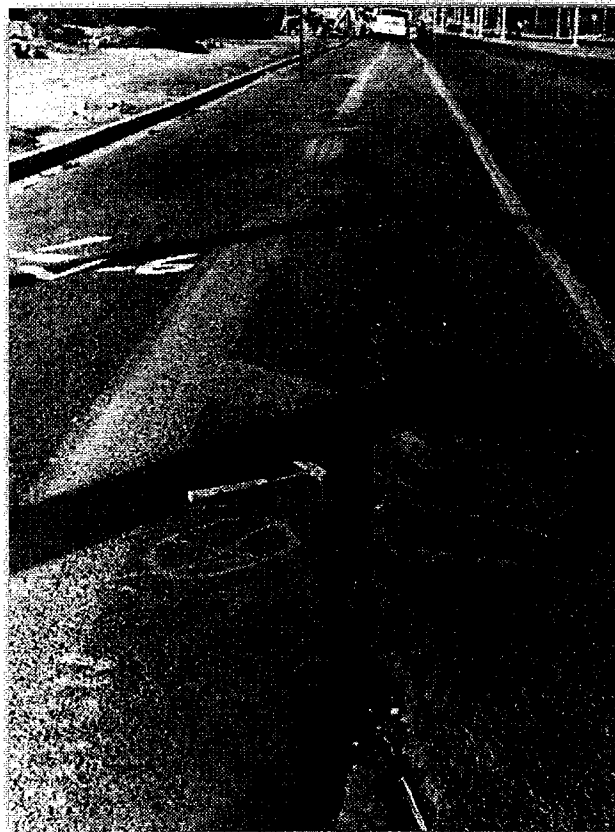
Figure 3a: Sulfate heave distress on Stewart Avenue in Las Vegas, NV (Hunter, 1988).

of dollars per year; the City of Las Vegas spent close to \$2.7 million to repair and maintain the pavements damaged by sulfate-induced heave in the late 1980s.

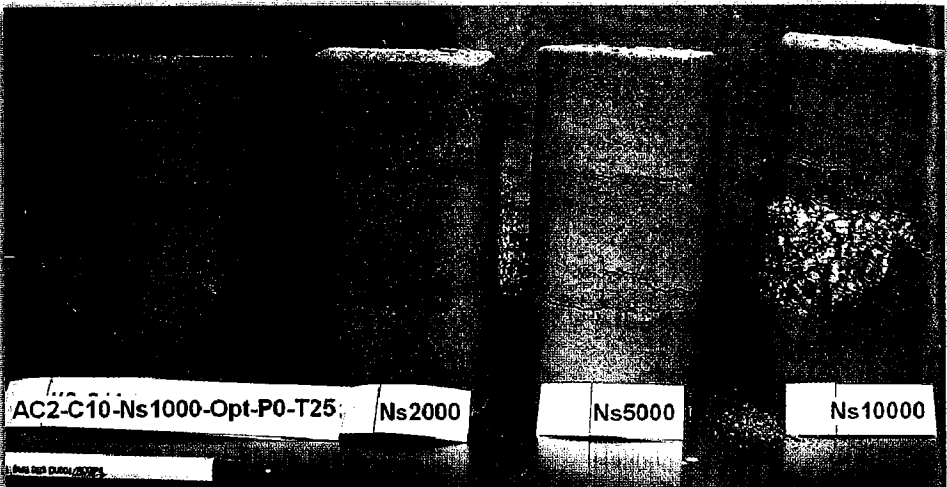
Figure 4. Cement-treated soil samples at different sulfate levels after curing.

One recent study sponsored by the National Science Foundation showed that the problematic levels vary for cement and lime treatments and their dosage levels. Figure 4 shows various treated soil specimens that were cured prior to strength testing. The specimen on the far right experienced severe heaving during curing, with clearly visible bulging. Based on swell strain magnitudes measured, the problematic sulfate levels varied between 1,000 ppm for soil-cement treatments to 2,000 ppm for lime treatments. Each specimen with different sulfate levels was stabilized with ordinary Portland cement.
